GMCA427

2011-2015 CHEVROLET/GMC, SILVERADO/ SIERRA,
HD2500-3500, DURAMAX, DOWN PIPE
CARB EO# D-763

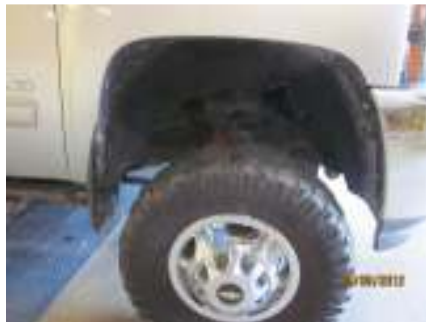
Figure 1

1. Remove the passenger side inner fender. See **Figure 1**.
Note: we also removed the Grille Assembly to prevent damage to it during the removal or installation of the down pipe.
2. Remove the hex bolt securing the down pipe to the exhaust manifold. Remove the sensor located just above the hex bolt. The V-Band clamp connecting the front pipe to the down pipe can also be removed. Save the hex bolt, sensor and V-band clamp for the installation. See **Figure 2**.
3. The front pipe needs to be temporarily removed. Carefully disconnect all sensors and loosen the four flange nuts on the rearward part of the front pipe. The transmission cross-member will need to be temporarily dropped to remove the front pipe. Remember to support the transmission with a block or jack stand while doing the transmission cross member is removal. See **Figure 3**.

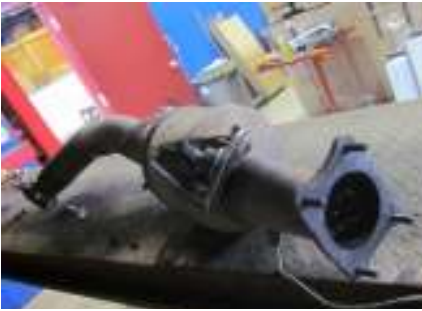
Figure 4

4. The front pipe also has a hanger mounted to the transmission that will also have to be removed. **Figure 4** shows the front pipe assembly removed.
5. The heat shield on top of the turbo will need to be removed. There is also a shield on the back of the down pipe. It runs along the firewall that needs to be removed. The 2 stock sensors on the top of the down pipe need to be carefully removed. Set the sensors aside and save for the installation. The stock V-Band clamp can be removed save for the installation. From the underside of the vehicle carefully slide the stock down pipe out between the frame and transmission.

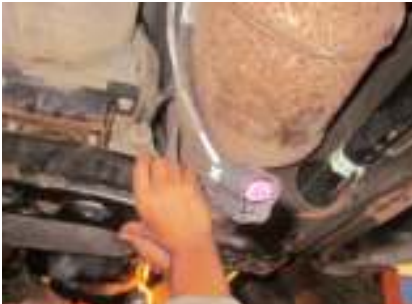
Figure 8

1. Start the install by sliding the **Down Pipe** up from the underside of the vehicle or the passenger side wheel well. Mate the flange up to the turbo and install the V-Band clamp at the turbo. Leave the clamp loose enough for some rotation.
2. Loosely securing the **Down Pipe** to the exhaust manifold with the hex bolt from the stock down pipe. Finish tightening the V-Band at the turbo and then finish tightening the bolt on the exhaust manifold.
3. Install the stock sensors into the **Down Pipe**. One is located along the lower section of the **Down Pipe** (**Refer to Figure 8.**) The other two sensors are located closer to the turbo.
4. The front pipe can then be reinstalled using the stock hardware and V-Band clamp. **Refer to Figures 8 & 9.**

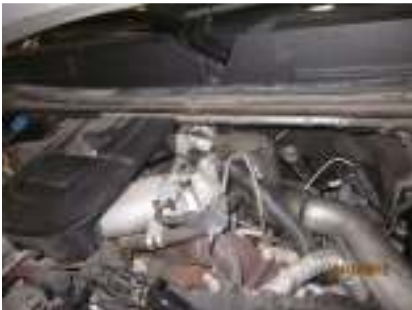
Figure 10

5. Reinstall the exhaust hanger to the transmission cross member. Reinstall the transmission cross member. Reconnect all the sensors to the front pipe.
6. Reinstall the passenger side inner fender.
7. Reinstall the turbo heat shield. **Refer to Figure 10.** Check along the exhaust to make sure all connections are tightened. Check along the whole length of the exhaust system to ensure that there is adequate clearance around the spare tire, fuel and brake lines or any wiring. If any interference is detected relocate or adjust.
