S7040

2020-UP CORVETTE C8 - CAT BACK
VALVE DELETE W CARBON FIBER TIPS
EXCEPT 2021-2022 MODELS W NPP
EXHAUST

MBRP®

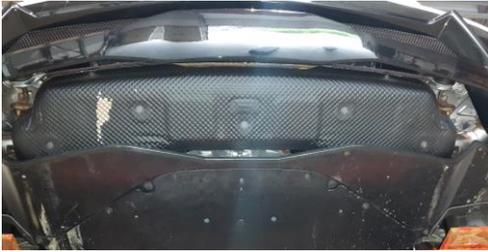
Figure 1

2. Remove the 7mm hex head screws, and 2 plastic push pins along the lower edge of the rear fascia. Remove both rear mud guards followed by the 4 torx head screws located behind them [2 per side] which secure the fender liners to the rear fascia.

Refer to Figures 1 and 2.

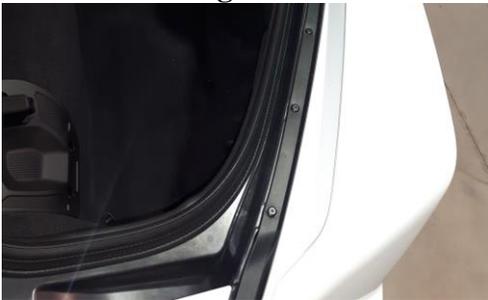
Figure 3

3. Remove the torx head screws along the upper edge of the rear fascia. **Refer to Figure 3.**

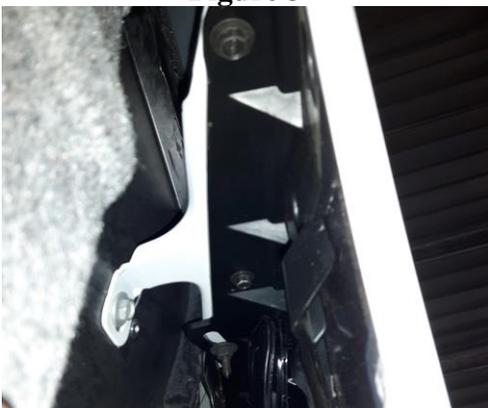
Figure 4

4. Pull back the fender liner and remove the two 7mm hex head screws, and M6 flange nut from both sides of the vehicle that secure the rear fascia to the quarter panels.

Refer to Figure 4.

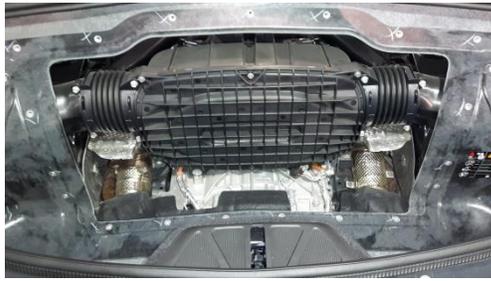
Figure 5

6. Remove the trunk liner to gain access to the engine cover. Remove the torx head screws and remove the engine cover.

Refer to Figure 5.

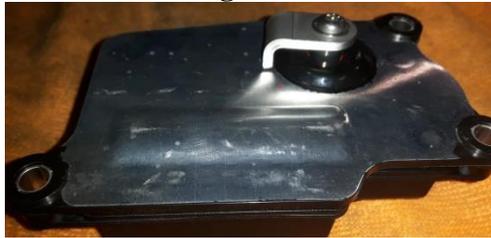
Figure 6

1. Remove the AFM actuators from the OEM exhaust. Remove the OEM arms from the actuators and install the supplied **Actuator Arm Bracket**.

Refer to Figure 6.

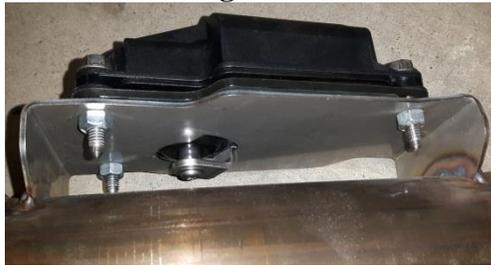
Figure 7

2. Install the AFM actuators onto the **Driver-Side Downpipe** and **Passenger-Side Downpipe** using the OEM bolts and the supplied **M6x1.0 Locknuts**.

Refer to Figure 7.

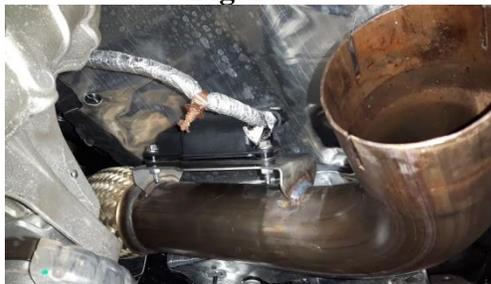
Figure 8

3. Install the **Passenger-Side Downpipe** using the previously removed M8 Flange nuts. Connect the wiring harness to the AFM actuator. Be sure the OEM gasket is in place.

Refer to Figure 8.

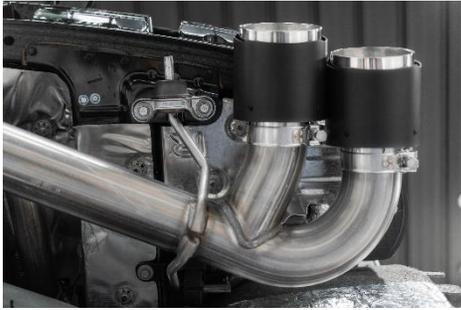
Figure 10

6. Install an OEM rear Isolator and a **3.0" Swivel Clamp** onto the **Passenger-Side Tailpipe Assembly** before installing it onto the vehicle. Ensure the forward hanger is installed into the front isolator. Secure the rear isolator with the previously removed bolts.

Refer to Figure 10.

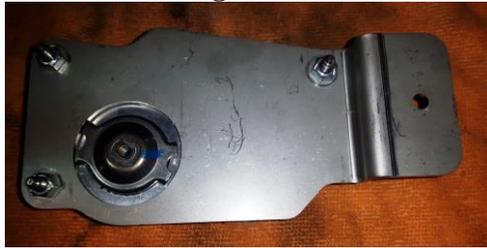
Figure 11

8. Install the NPP actuators onto the supplied **NPP Actuator Brackets** using the OEM bolts and the supplied **M6x1.0 Locknuts**. Refer to **Figure 11**.

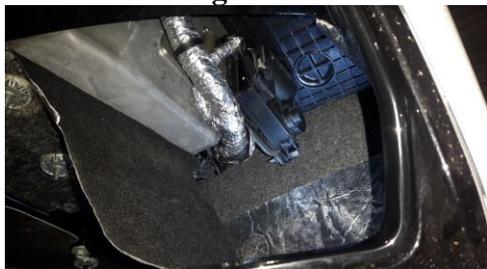
Figure 12

9. Remove the wiring harness clips from the M6 studs located above the exhaust outlets and install both **NPP Actuator Brackets**. Secure the brackets with the supplied **M6x1.0 Flange Nuts**. Reconnect the wiring harness to the actuators.

Refer to **Figure 12**.

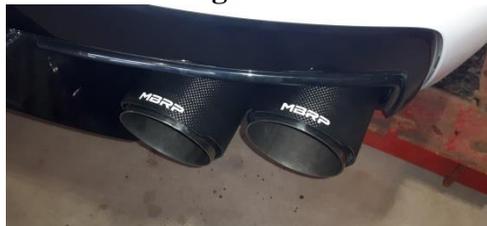
Figure 13

11. Install the **Tips** and align to your preference. Complete the final adjustment of the tailpipe assemblies and tighten all clamps. **NOTE: the X Pipe assembly can be swung front to back to adjust the center position of the tips in the rear facia. The X Pipe Assembly can also be shifted left or right in the Passenger-Side Downpipe expansion joint to adjust the lateral position of the Tips.**

Refer to **Figure 13**.
